# Manhole Inspection Summary

Manhole # S09UU\_009MH

Insp Date: **2/19/09 11:25 AM**

**Location** Address: **3501 FOREST PARK AVE**

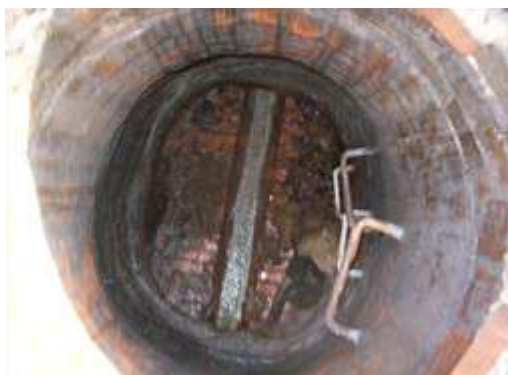
Defect 1

Condition: ☐ Sound ☐ Cracked ☐ Root Intrusion ☐ Deteriorated ☐ Leaks ☒ **Debris**

LOTS OF DEBRIS ON BENCH AND IN CHANNEL.

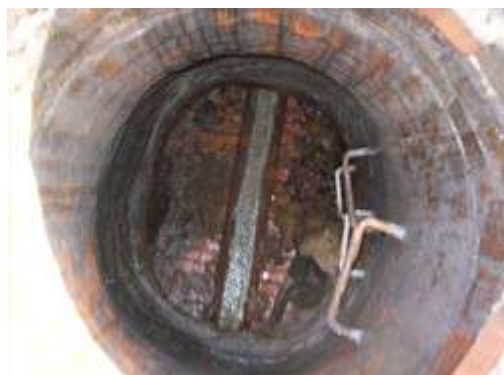
Defect 2

Count: **4** Missing: **0** ☒ **Corroded**

☒ **Evidence Of Surcharge** Depth: **2** (ft.) ☐ Active Surcharge Present

evidence surcharge; debris; corroded step

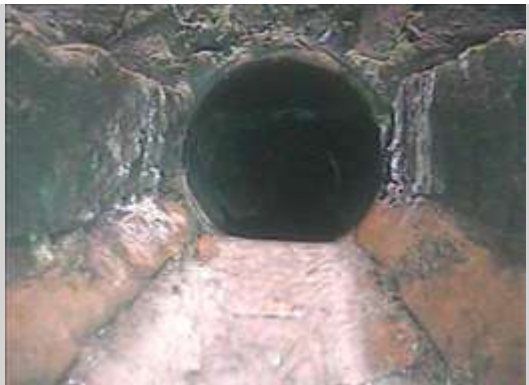
6 O'Clock Inflow

Deposits: ☐ None ☐ Mud ☐ Sludge ☒ **Debris** ☐ Grease

Silt Depth: **5** (in.) Deposits Extent: **Medium**
